NASA CR-112119-2

**EVALUATION OF COATED COLUMBIUM ALLOY
HEAT SHIELDS FOR SPACE SHUTTLE
THERMAL PROTECTION SYSTEM APPLICATION**

PHASE II ♦ SUBSIZE HEAT SHIELD AND SMALL SIZE TPS EVALUATION

Prepared by
CONVAIR AEROSPACE DIVISION OF GENERAL DYNAMICS
San Diego, California

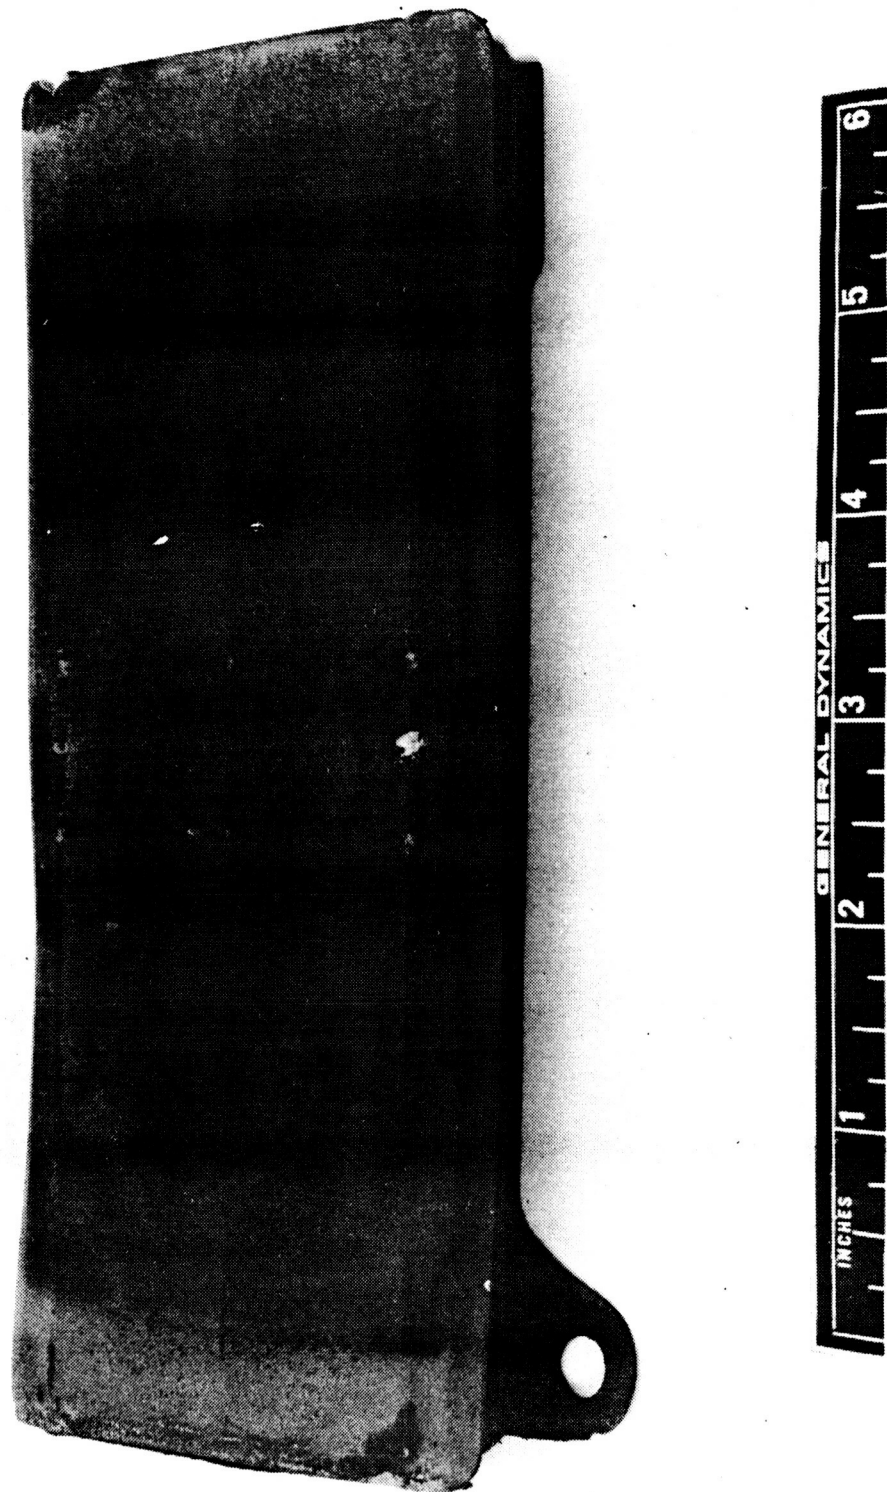
Figure 5-50. Front View of Panel BST-2 After 100 Flight Simulation Cycles -
34 Cycles After Coating Repair (Photo 125705B)

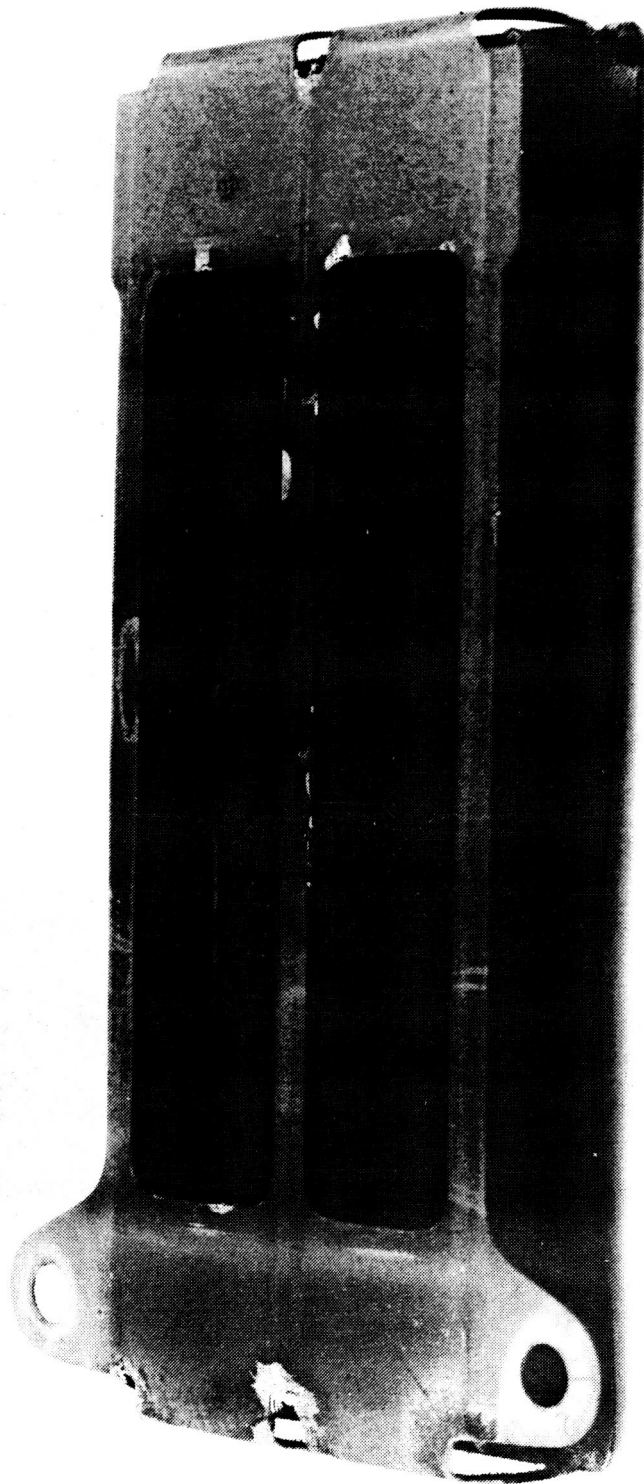
Figure 5-51. Rear View of Panel BST-2 After 100 Flight Simulation Cycles -
34 Cycles After Coating Repair (Photo 125704B)

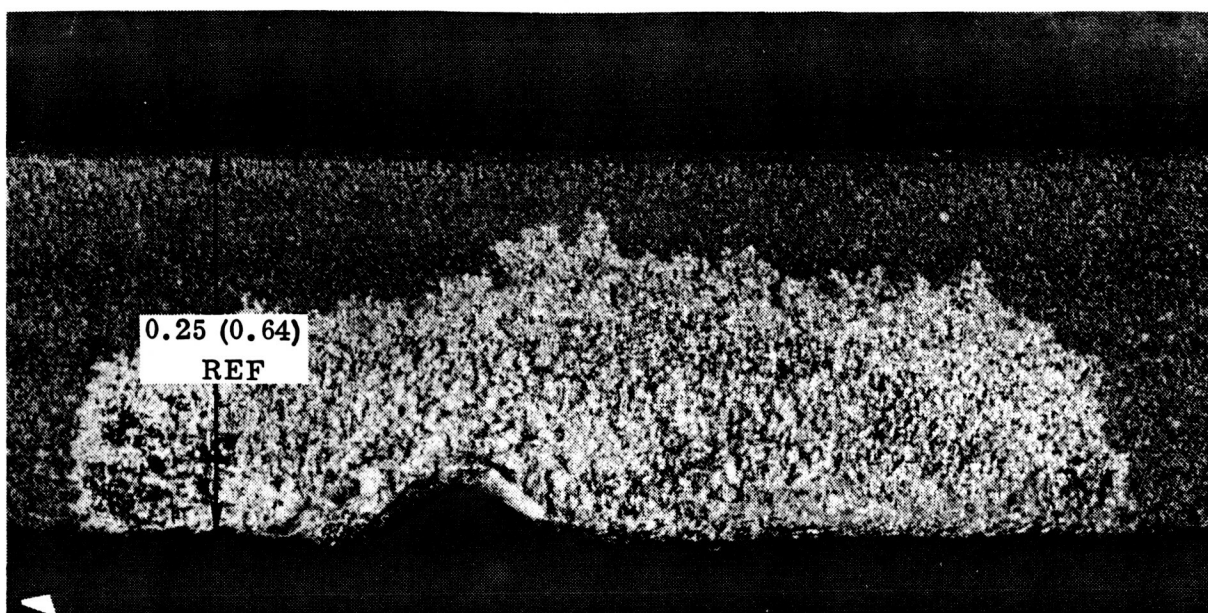
Figure 5-52. Close-up View of Panel BST-2 After Coating Repair Before Further Flight Simulation Cycling (Photo 125207B)

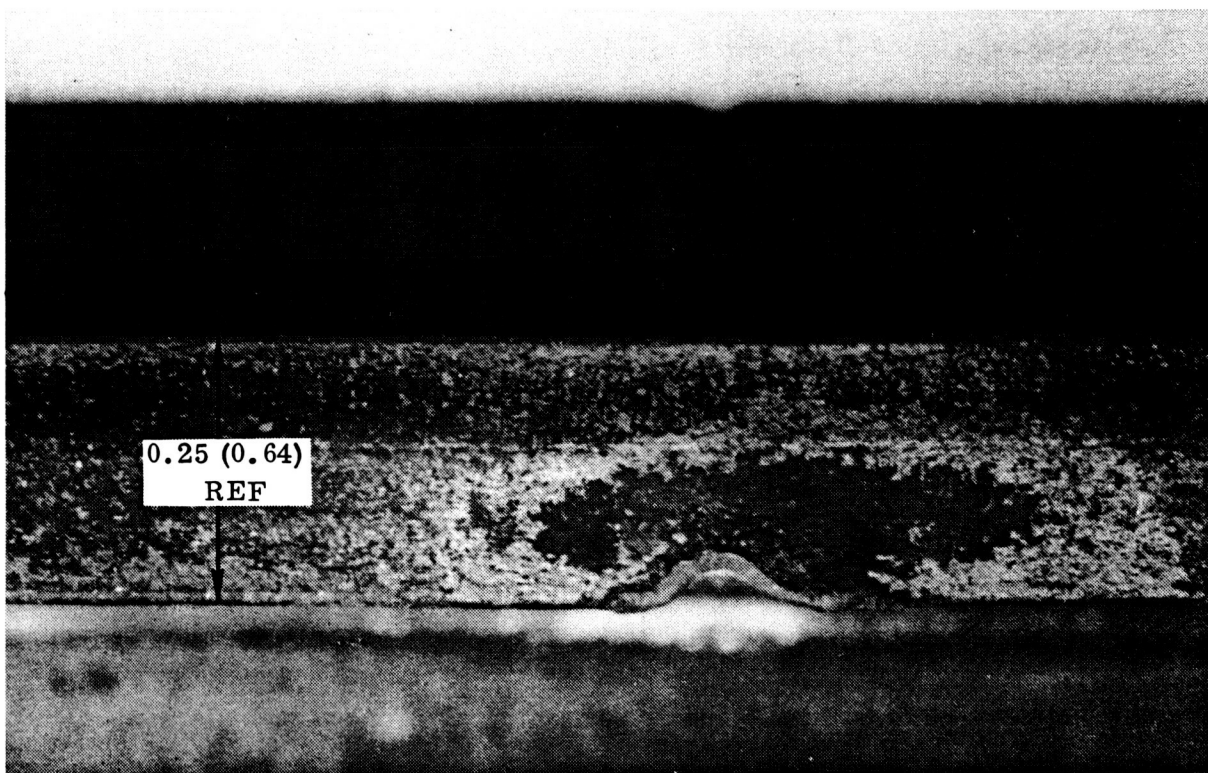
Figure 5-53. Close-up View of Panel BST-2 After Coating Repair and Further Cycling to 100 Flight Simulation Cycles (Photo 125713B)

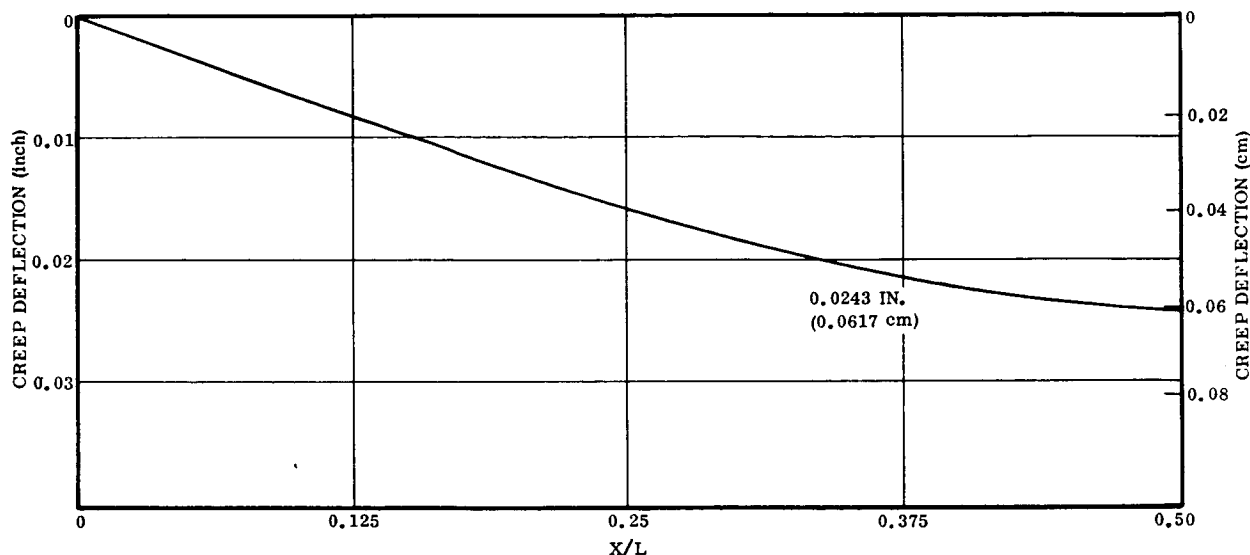
Figure 5-62. Predicted Creep Deflection Along Semi-Span of Corrugated Panel (100 Cycles)

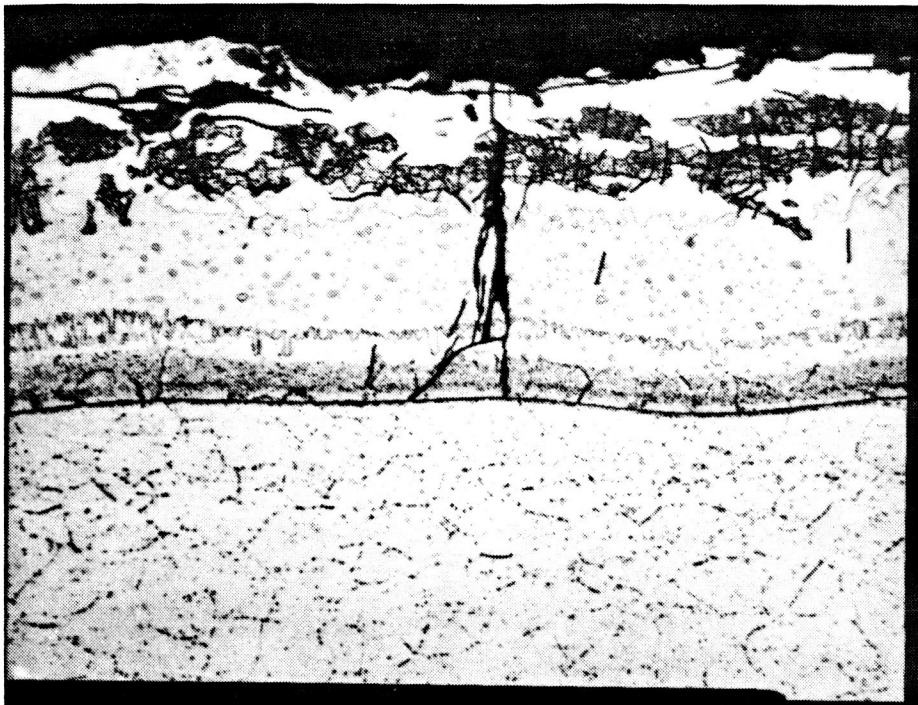
Magnification: 500X
 Etch: Light
 Panel No.: BSC-5
 Flight Cycles: 0
 Location: 9
 Negative No.: D-2755
 Mount No.: 467-P

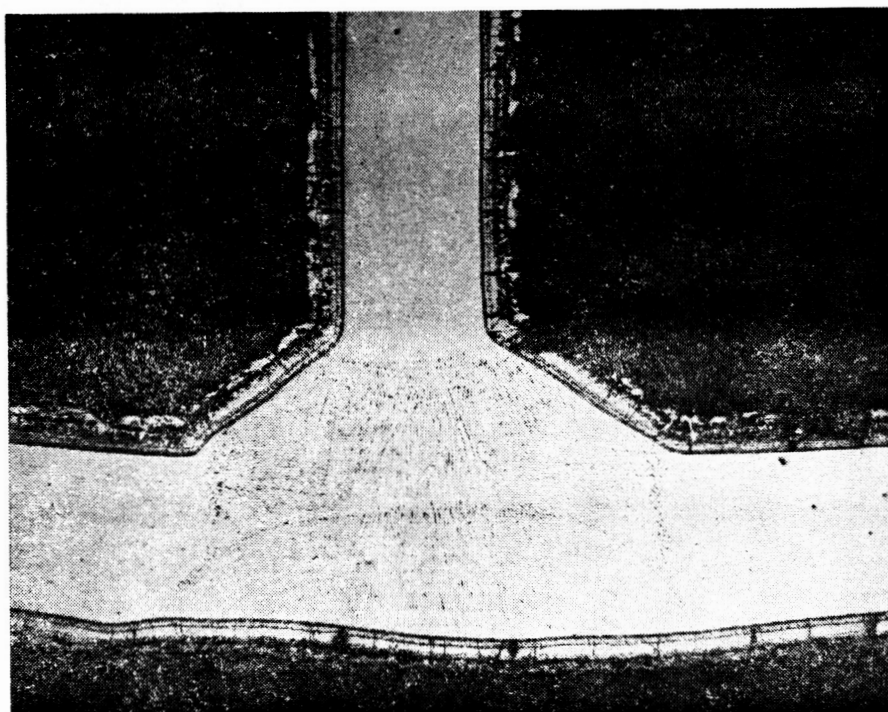
Magnification: 50X
 Etch: Light
 Panel No.: BST-5
 Flight Cycles: 0
 Location: 2
 Negative No.: D-2741
 Mount No.: 470-P

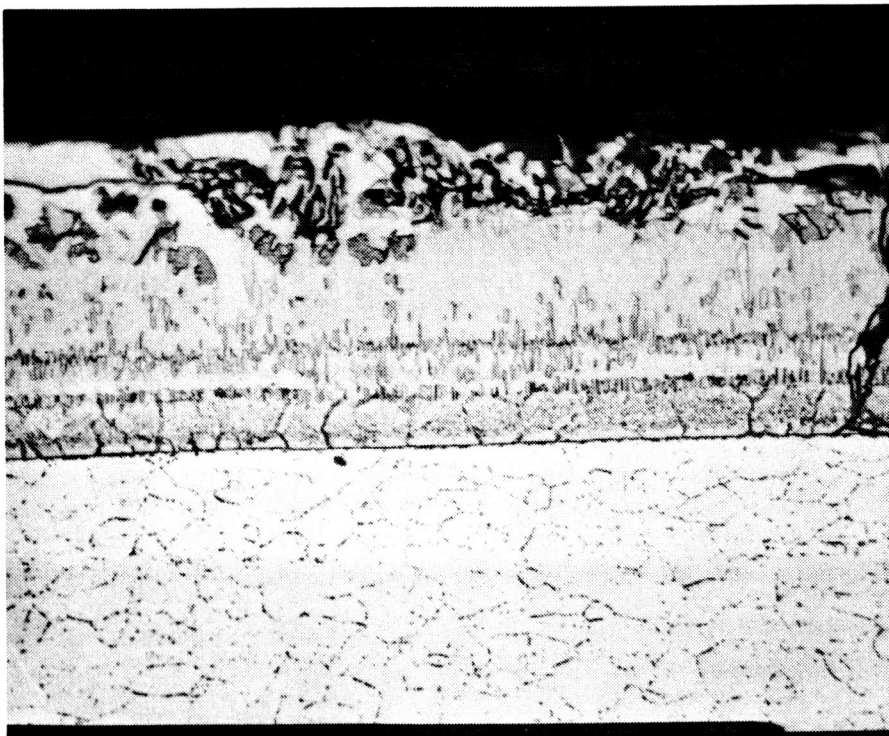
Magnification: 500X
 Etch: Light
 Panel No.: BST-5
 Flight Cycles: 0
 Location: 2
 Negative No.: D-2743
 Mount No.: 470-P

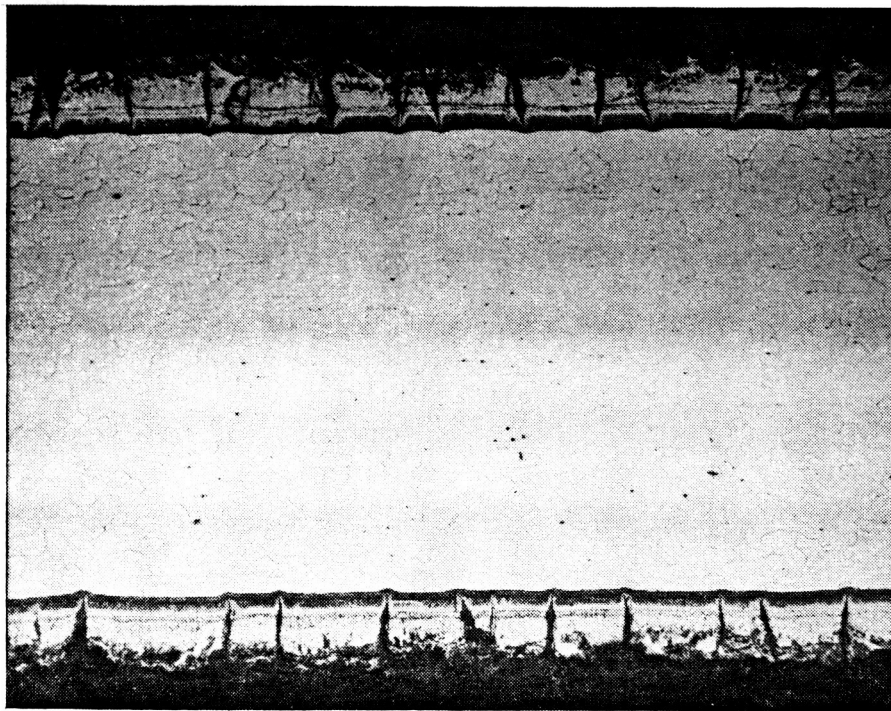
Magnification:	100X
Etch:	Light
Panel No.:	YSC 3
Flight Cycles:	100
Location:	9
Negative No.:	D-2837
Mount No.:	477-P

5.7.2 Group 1, C-129Y/R-512E, corrugated. - The two panels of this group completed 100 flight simulation cycles with no visible evidence of coating breakdown or substrate attack. These visual observations were confirmed by the metallographic examination of panel YSC-3. Neither substrate erosion nor oxygen contamination was observed in any of the examined regions. The effectiveness of the coating is clearly shown in Figures 5-72 to 5-74 which were taken from the center of the panel where the test temperature was maximum. After 100 cycles, the coating cracks have enlarged and filled with a grey oxide but have not penetrated through the diffusion zone into the alloy substrate. Some of the grey oxide is also visible on the outer surface of the coating. The anodizing etch used in Figure 5-74 is especially effective in showing the oxide-filled cracks in addition to its main purpose of indicating oxygen contamination. No oxygen contamination was found in this specimen. Figures 5-75 and 5-76 were taken from the corner of the panel (location 13). Because of the steep temperature gradient in the simulator, this area remained relatively cool during cycling and shows almost no effect from the 100 cycles. A thin oxide layer is visible at the outer edge but the coating cracks (see Figure 5-76) have not appreciably increased in size. From a comparison of thicknesses of the center section, Figure 5-72, and the corner section, Figure 5-75, a substrate consumption by diffusion zone growth of about 0.0005 inch (0.0013 cm) per side in 100 cycles was determined.

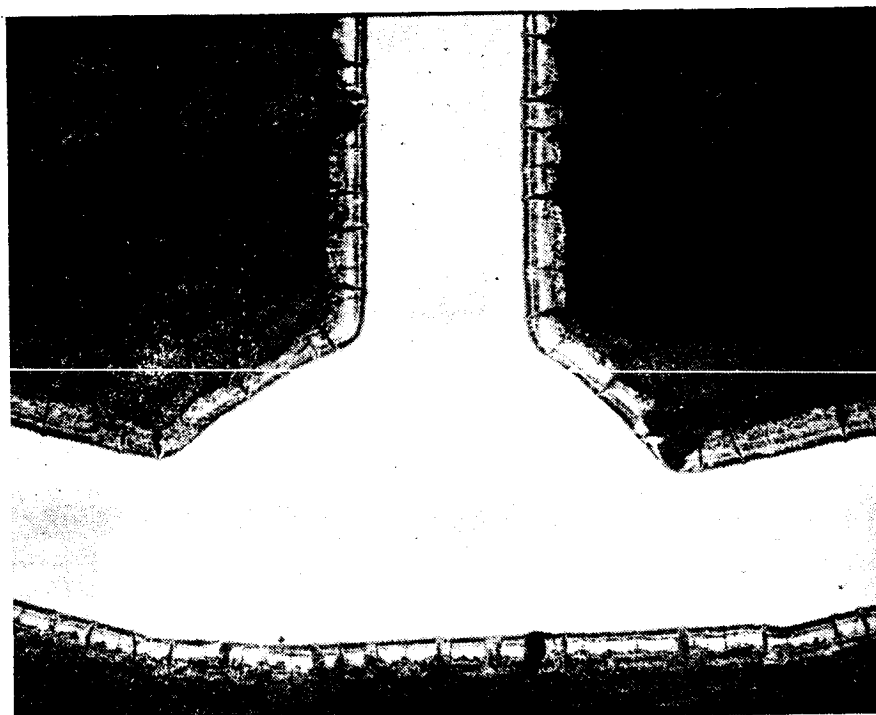
Magnification: 50X
 Etch: Light
 Panel No.: YST-3
 Flight Cycles: 100
 Location: 2
 Negative No.: D-2799
 Mount No.: 490-P

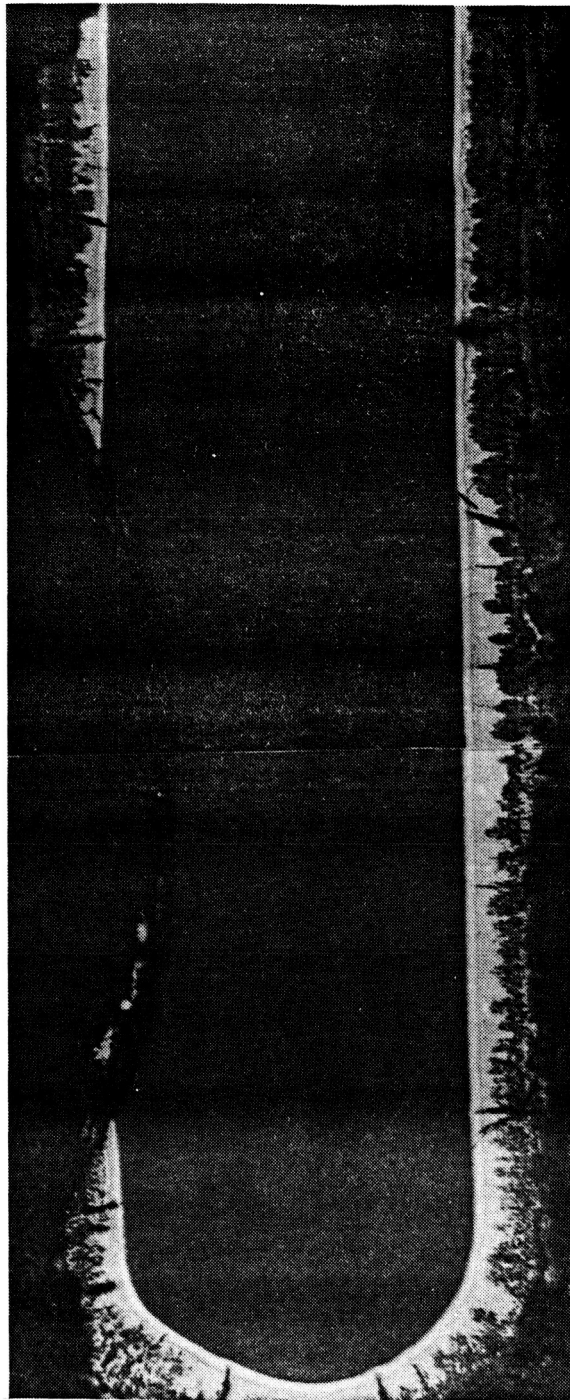
Magnification: 100X
 Etch: Anodized
 Panel No.: YST-4
 Flight Cycles: 64
 Location: 1
 Negative No.: D-2960
 Mount No.: 519-P

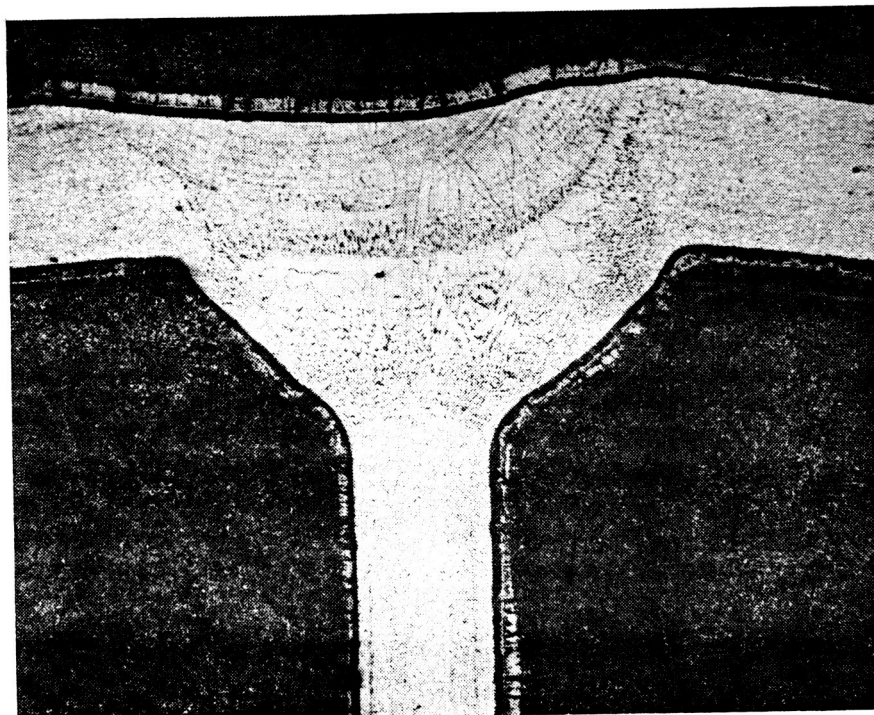
Magnification: 50X
 Etch: Heavy
 Panel No.: BST-3
 Flight Cycles: 100
 Location: 1
 Negative No.: D-2933
 Mount No.: 514-P

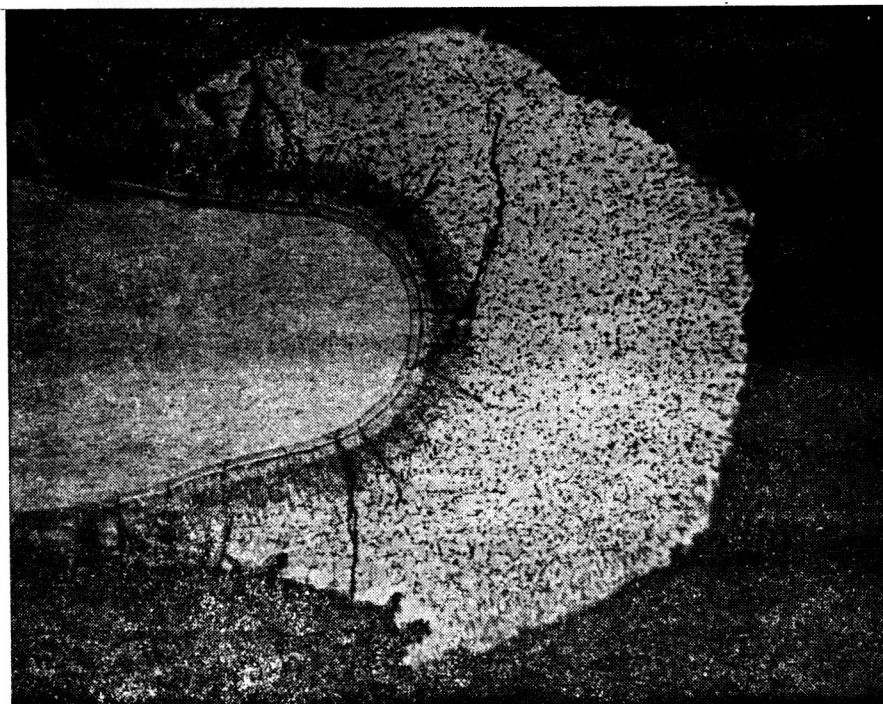
Magnification: 100X
 Etch: Light
 Panel No.: BST-2
 Flight Cycles: 100
 Location: 3
 Negative No.: D-3138
 Mount No.: 619-P

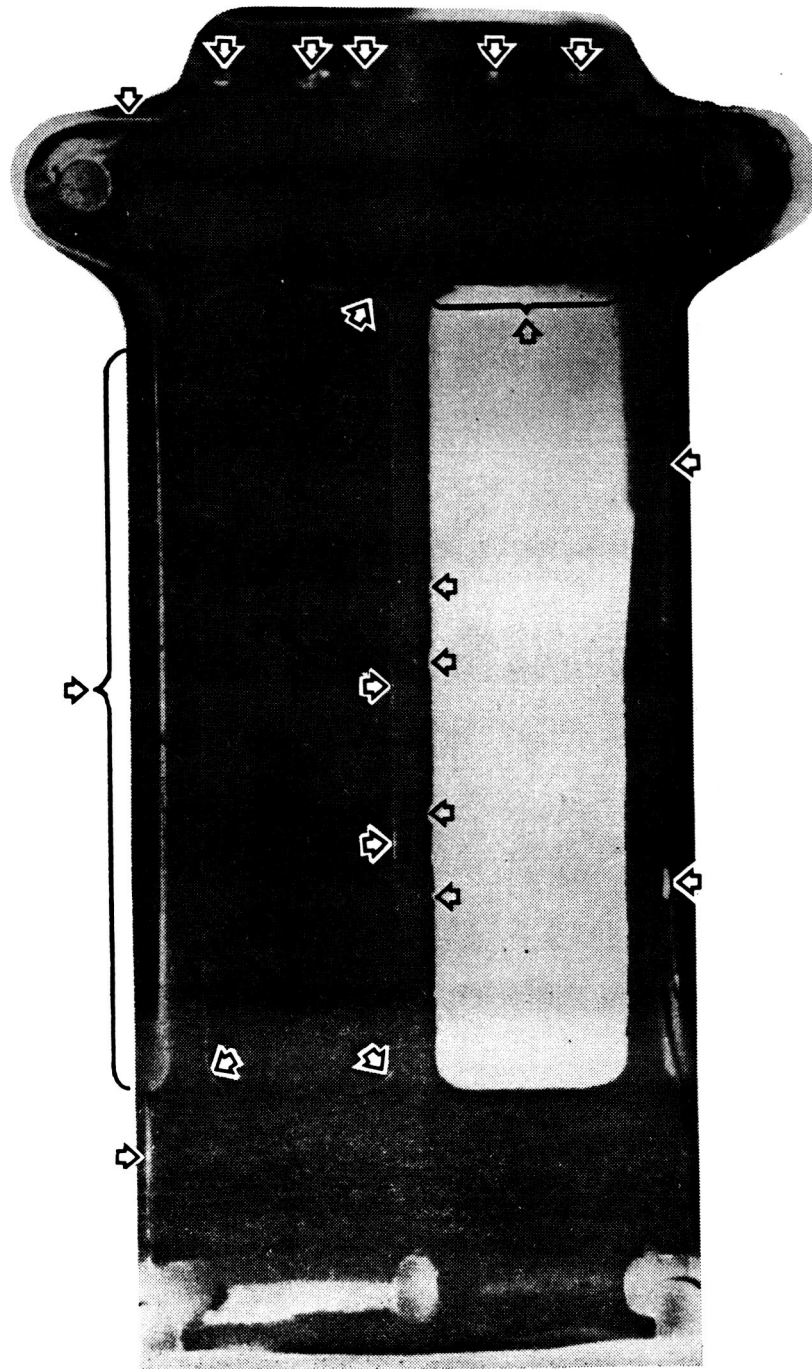
TYPICAL REGIONS OF
NON-WETTING INDICATED
BY ARROWS

Figure 5-115. Autoradiograph of Green Coating Showing Typical Lack of Wetting

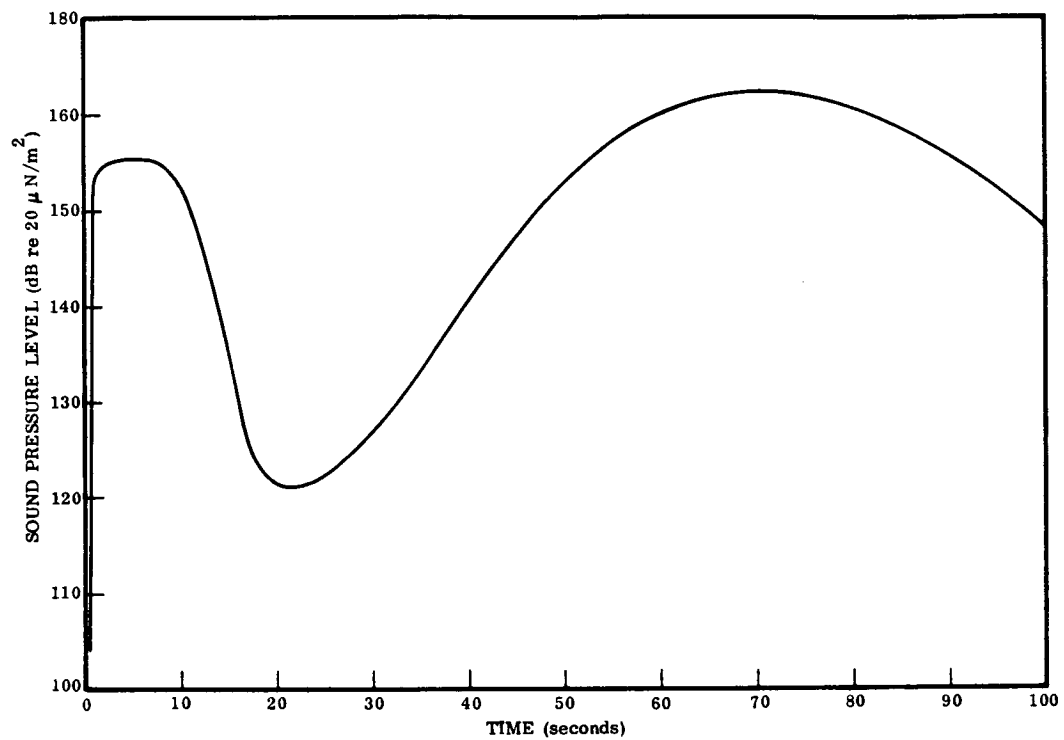
Figure 6-3. Boost External Noise Time History

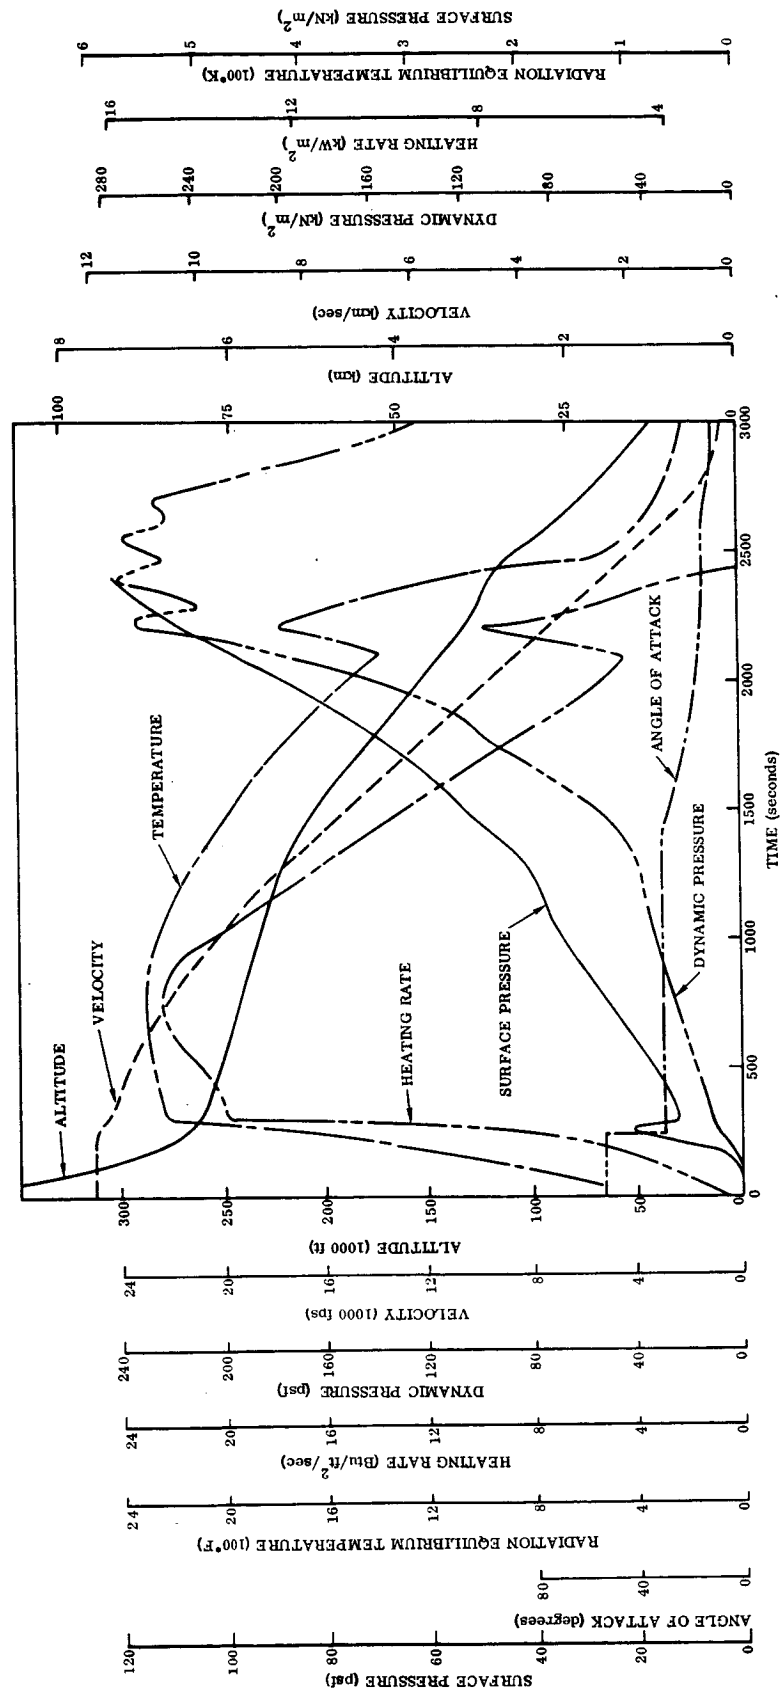
Figure 6-7. Selected Entry History - Lower Surface $X/L = 0.025$

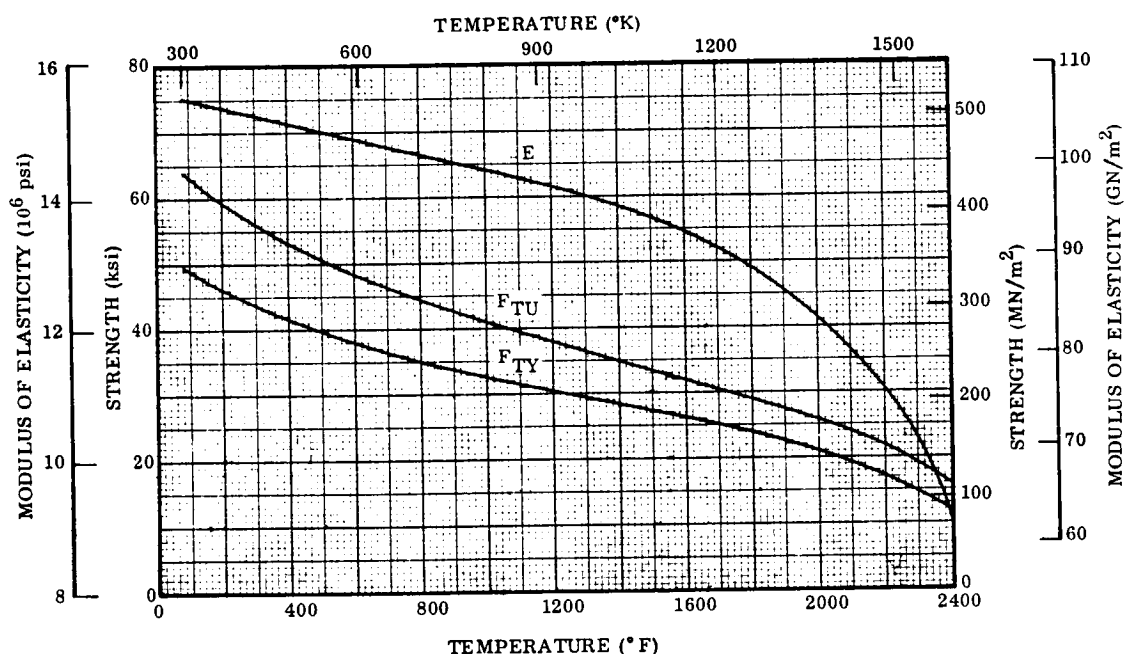
Figure 6-8. Preliminary Design Tensile Properties Versus Temperature for Cb-752/R-512E Based on Net As-Coated Section

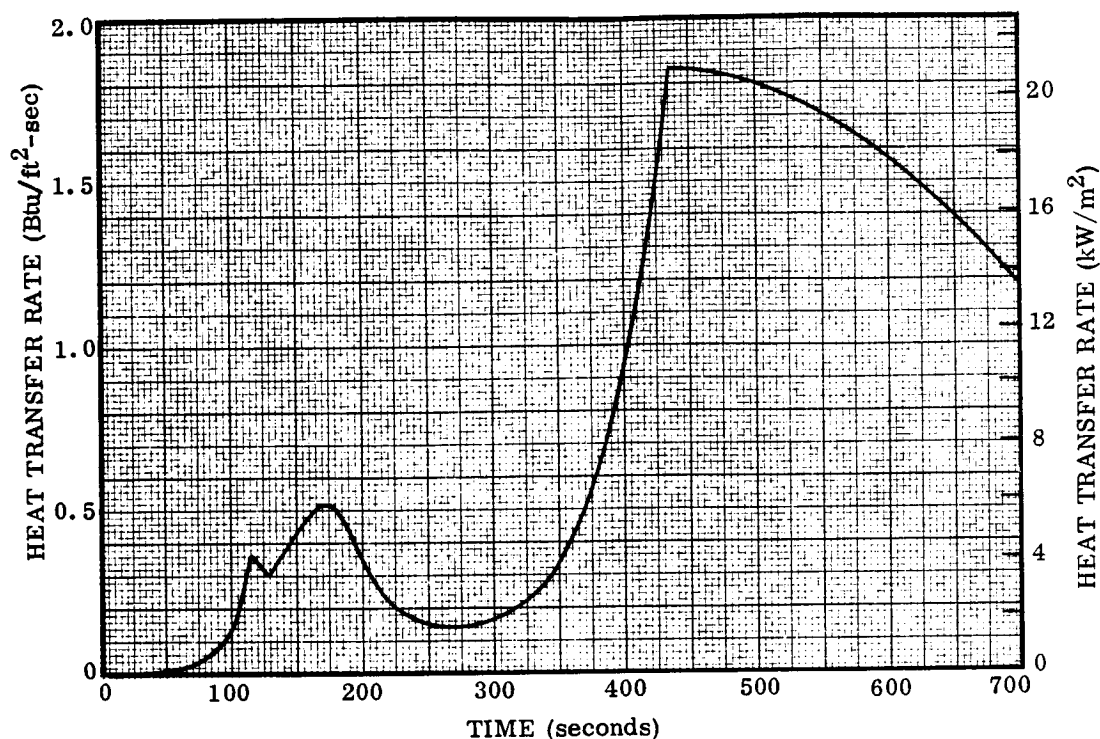
Figure 6-29. Boost Heating Rate History (Lower Fuselage, X/L=0.025)

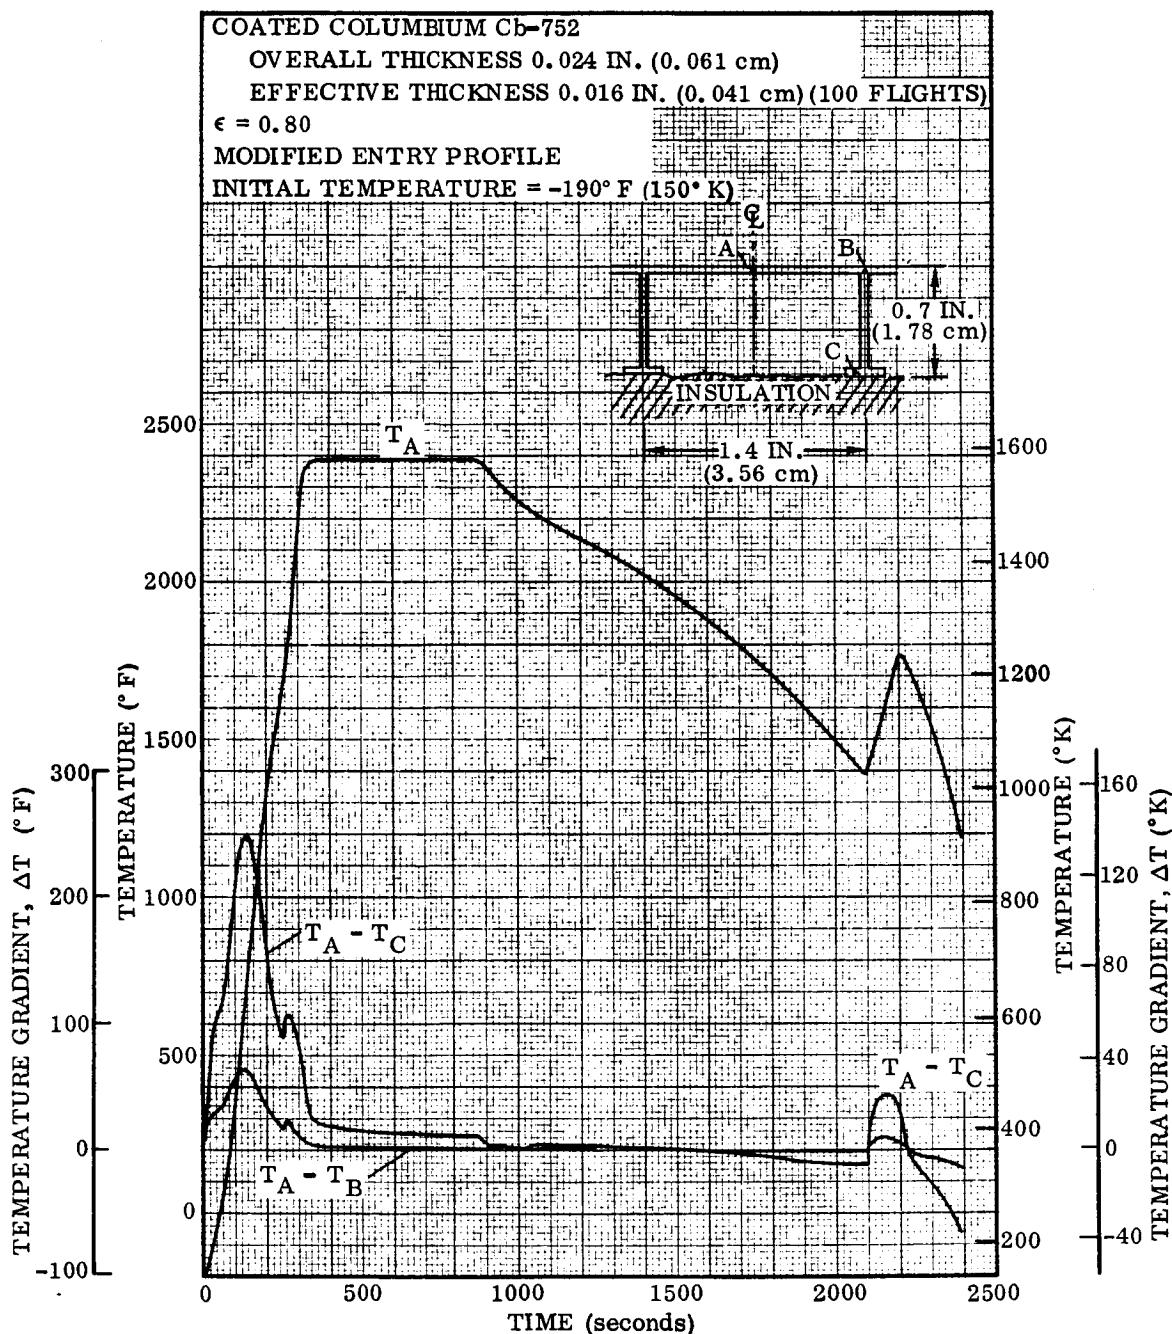
Figure 6-38. Predicted Tee-Stiffened Panel Temperatures During Entry

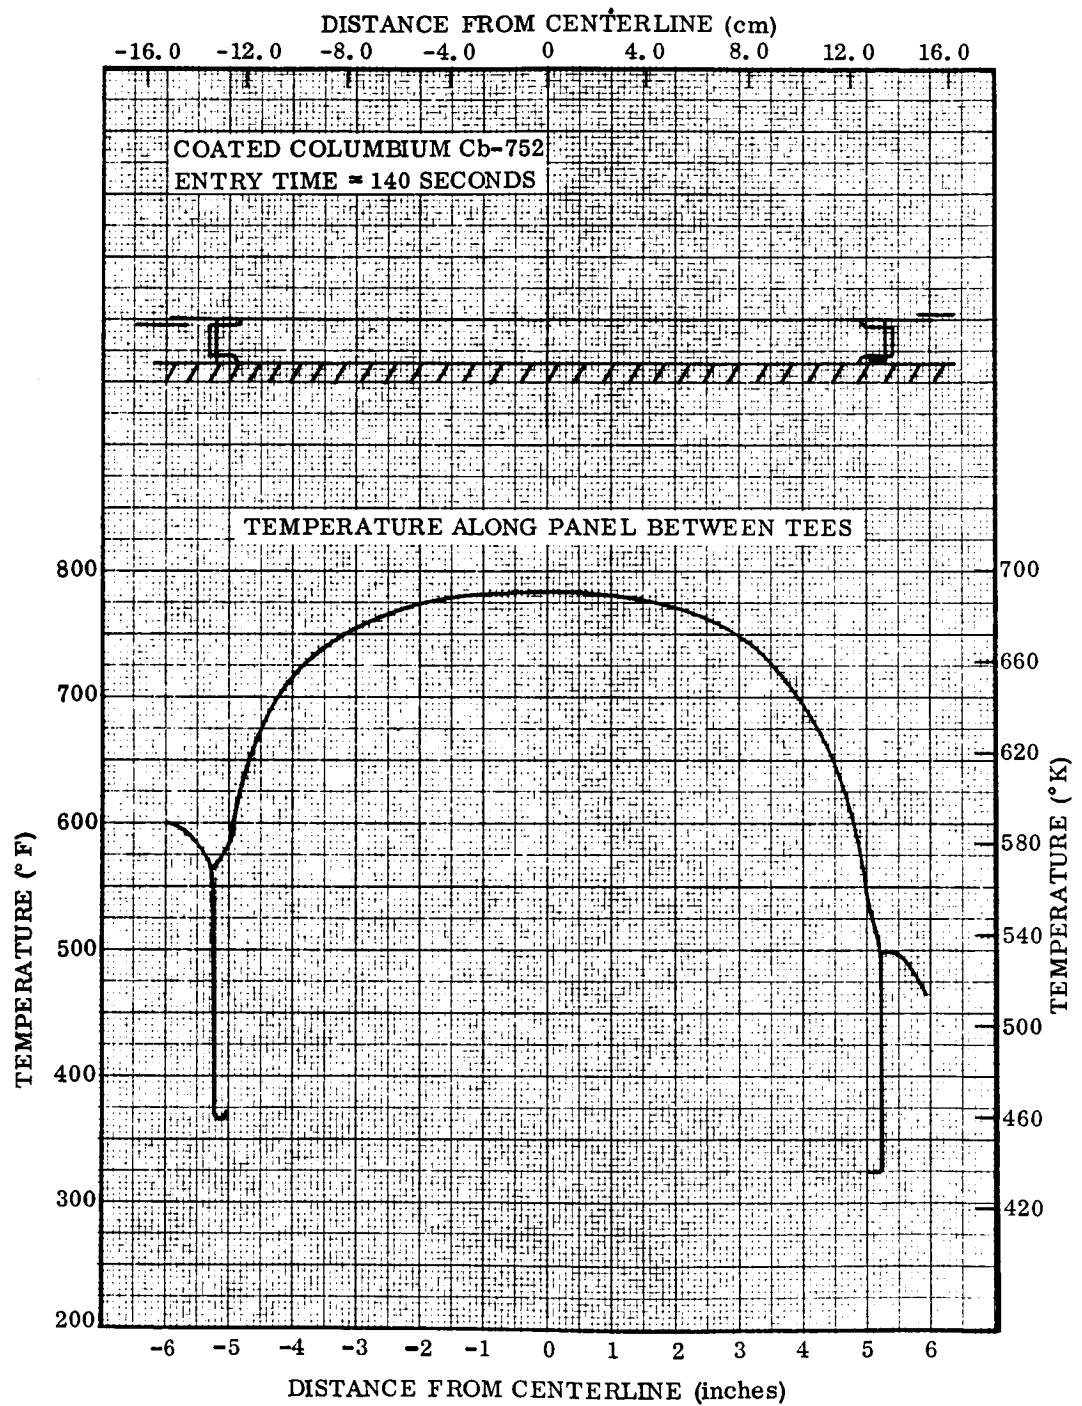
Figure 6-43. Predicted Tee-Stiffened Panel Temperature Distribution Along the 12-Inch (30.48 cm) Length Between Tees

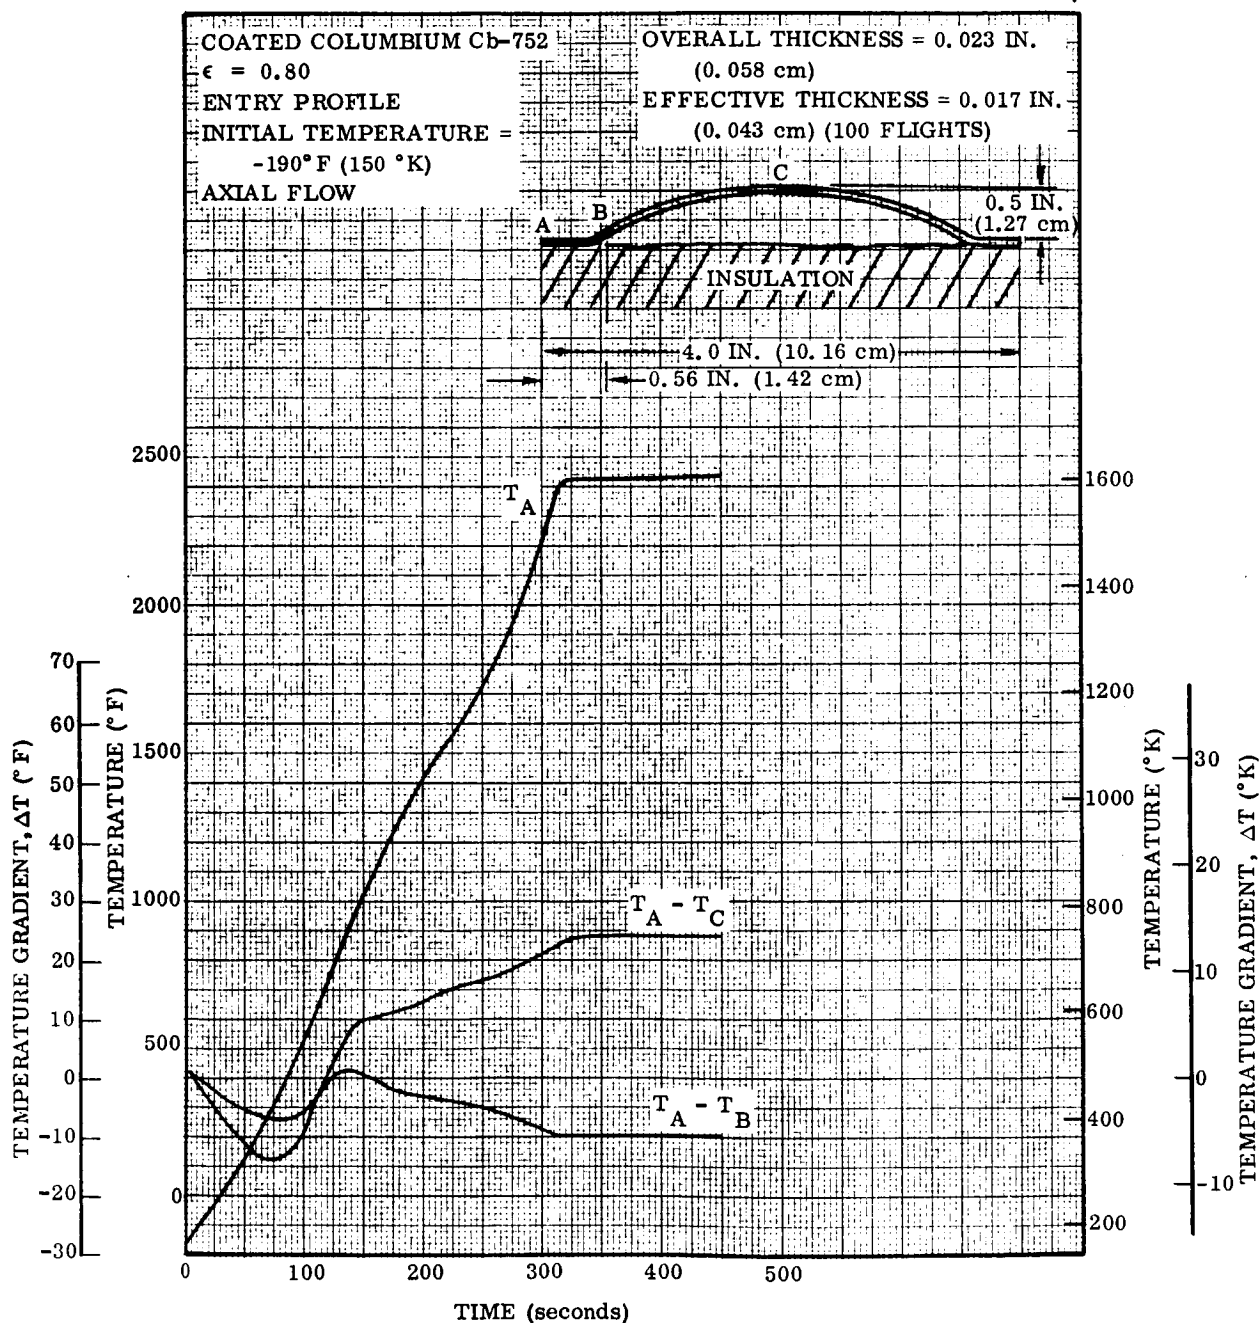
Figure 6-44. Predicted Corrugated Panel Temperature During Entry, Axial Flow

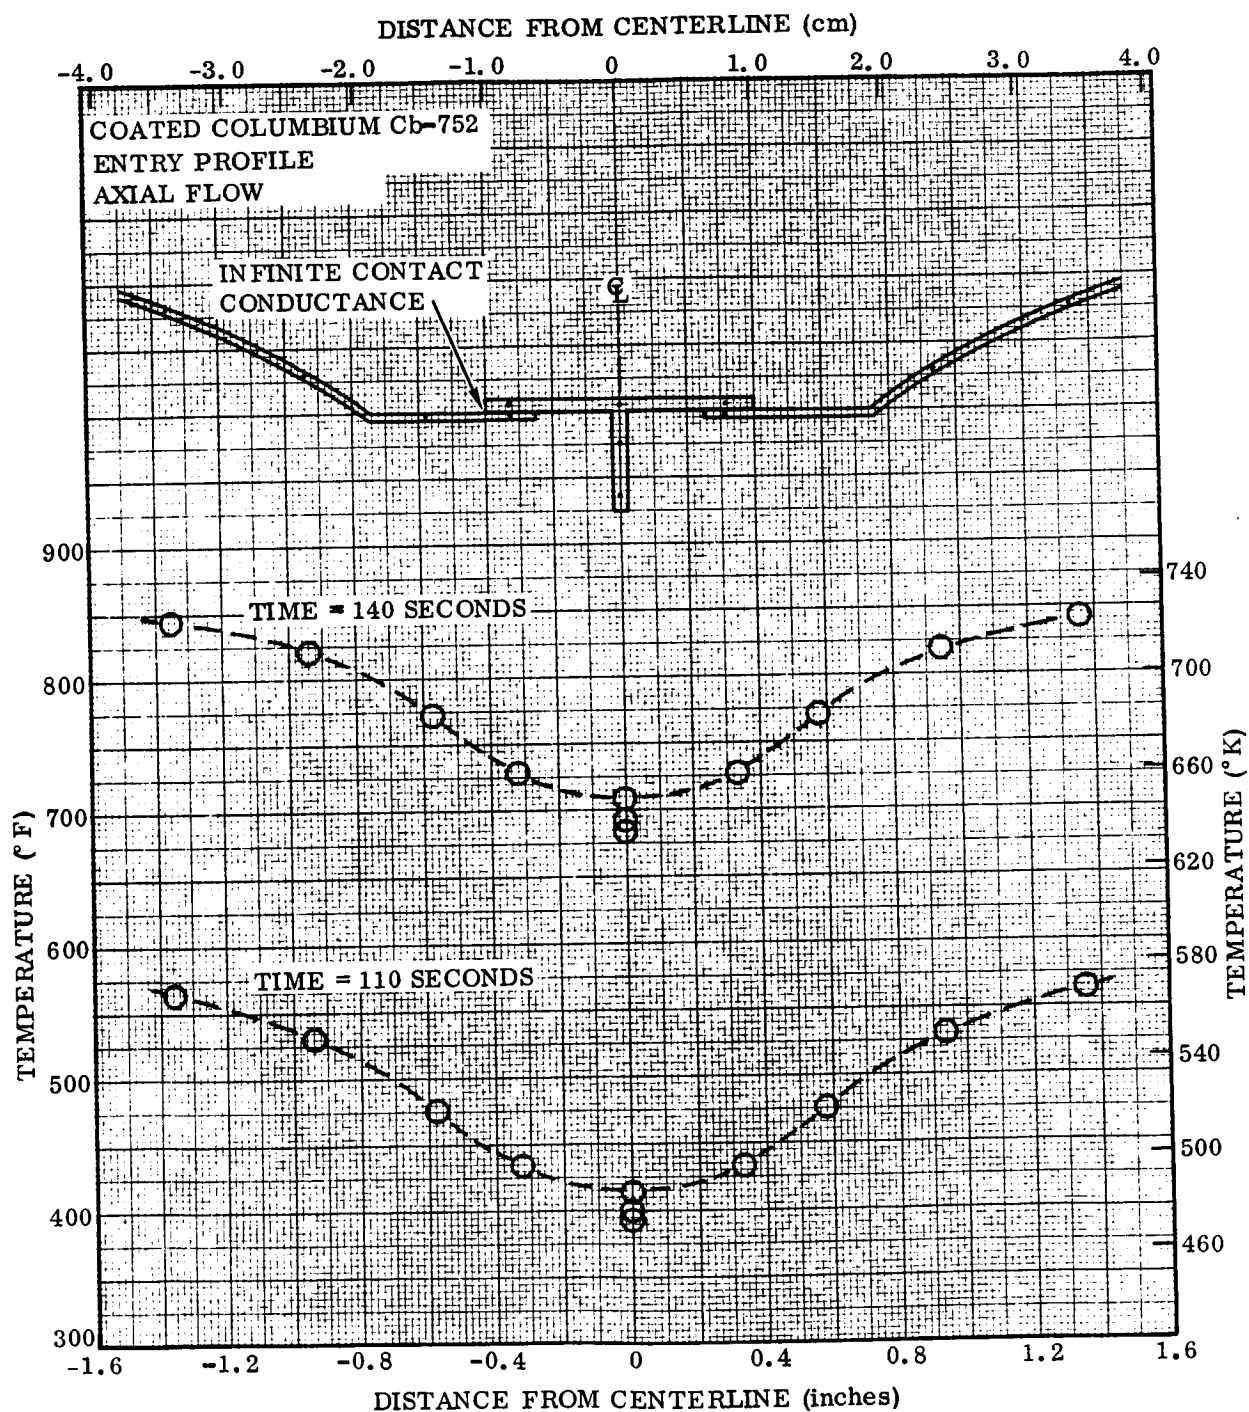
Figure 6-53. Predicted Corrugated Panel Edge Structure Temperature Distribution Assuming Infinite Contact Conductance at Interface
